RE-Konnect

Risk Engineering Bulletin

February 2018 Vol. 2 | Issue 3

A number of recent fires around the world in which such external claddings are implicated is worrying. In this issue of RE-Konnect, we provide you with a brief overview on the mechanism of fire spread in external claddings, some recent catastrophic high-rise fires and loss prevention measures to minimize high-rise fires.

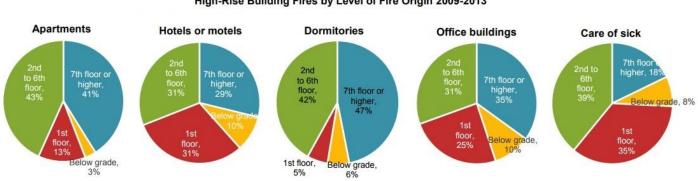
Ten percent of hotel and office building high-rise fires actually started below grade. The figure shown below presents a general breakdown of level of origin for the five different occupancies.

High-Rise Building Fires by Level of Fire Origin 2009-2013

Most high-rise building fires begin on floors no higher than the 6th story. Statistics show that 47% of dormitory high-rise fires began on the 7th floor or higher, as did 41% of the apartment high-rise fires, 35% of the office building high-rise fires, 31% of the hotel high-rise fires and 19% of the high-rise fires in facilities that cares for the sick.

Hotels, office buildings and facilities that care for the sick often have restaurants or cafeterias, small stores and other types of activities on the first floor. This may explain the higher percentages (25-35%) occurring on the first floor in these properties. Only 5% of the high-rise dormitory fires and 13% of the high-rise apartment fires began on the first floor.
